Re: Lake Nipmuc, Mendon, MA – 2024 Year End Report – DEP File #218-0725

Summary Of 2024 Management Activities

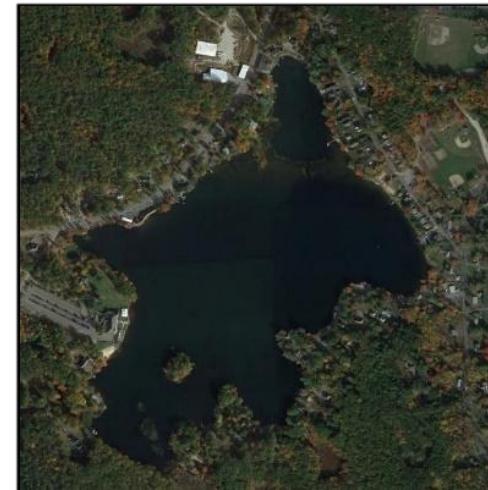
Figure 1: Lake Nipmuc - Mendon, MA

It is our pleasure to present the 2024-year end summary report to the Town of Mendon regarding the aquatic management program at Lake Nipmuc (pictured in Figure 1 to the right). Lake Nipmuc is approximately 85 surface acres and is located in Mendon, MA (adjacent to Route 16, Uxbridge Road). The Lake is primarily bordered by small woodlands mixed in with residential houses along each shoreline. The majority of the shoreline has a natural buffer. Water and Wetland used a small, private boat launch at the intersection of Uxbridge Road and Old Taft Avenue to launch the boat for each site visit.

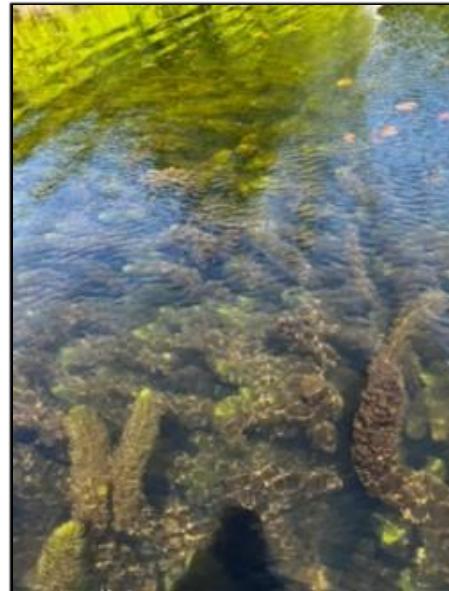
Figure 3: Variable milfoil prior to treatment during May 24th visit

Invasive variable milfoil (documented in Figure 3) was found in the typical areas consisting of the old Nipmuc Marina, the shallow cove near Alicante

Restaurant, and the southwestern cove near the outlet. The milfoil was documented as dense. Tape grass (*Vallisneria americana*), bladderwort (*Utricularia* sp.), and waterlilies (*Nymphaeaceae*) were found in

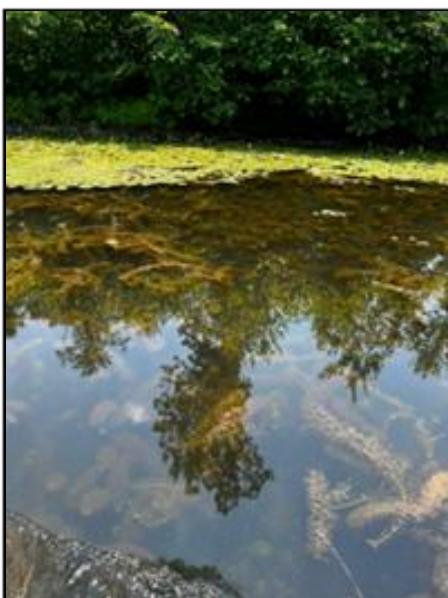
Figure 4: Variable milfoil surfacing during the June 20th visit

The conditions were consistent with our pre-management survey. As planned, a treatment was conducted (milfoil surfacing in Figure 4). The liquid contact herbicide was applied using a treatment boat equipped with a calibrated sub-surface injection system. This application methodology allows for even coverage within the treatment areas. The treatment went extremely well and conditions were good. Water clarity during the visit was excellent, without any visual signs of an algal bloom. The treatment focused on the old marina cove, the Alicante cove, and the area near the outlet. Prior to the treatment, the shoreline was posted by the Town of Mendon with neon signage noting the treatment, affiliated water use restrictions, and Water & Wetland contact information. The signs fulfill permit obligations for shoreline posting.

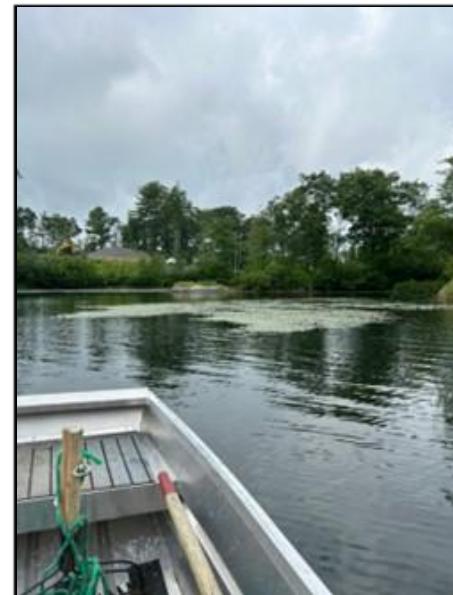
Figure 5: Water and Wetland conducting a post-treatment survey

A post-treatment survey was carried out at Lake Nipmuc to evaluate the effectiveness of the treatment from the previous visit (Figure 5). The survey concentrated on the treated areas, where the treatment was found to be successful, with only minor regrowth of variable milfoil at the bottom of the littoral zone. The rest of the Lake showed a healthy mix of native species with no visual signs of harmful blooms observed. Overall, the water clarity was excellent. Native species, such as tapegrass, bladderwort, watershield (*Brasenia schreberi*), and waterlilies were found in scattered patches throughout the Lake. There were also benthic and macro algae populating the bottom of the Lake at non-nuisance densities. It should also be noted that weather conditions at the time of survey were windy and rainy, which limited visibility in some areas.
